Inspection Report

Property address: Any Town USA

Inspection date: Wednesday, April 10, 2019

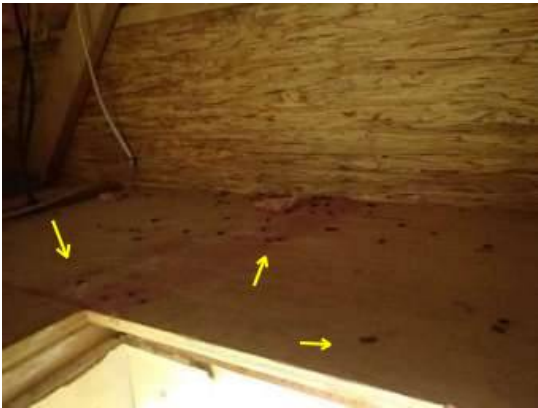
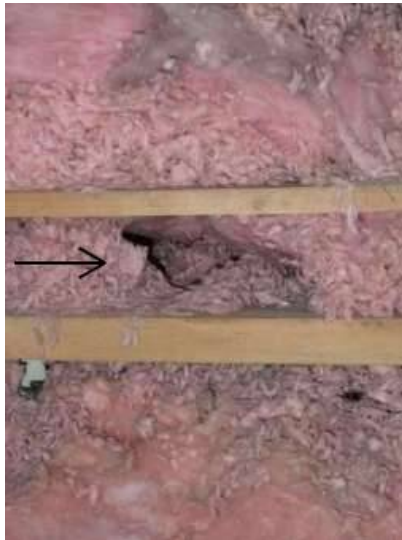
1) *Repair/Replace* - Evidence of rodent activity was found in the form of feces and nests in the attic both garage and second floor access. Consult with the property owner about this concern. A qualified licensed rodent exclusion contractor should make repairs to seal openings in the structure, set traps, and clean rodent waste as necessary. Some guidelines are provided in these Center for Disease Control articles:

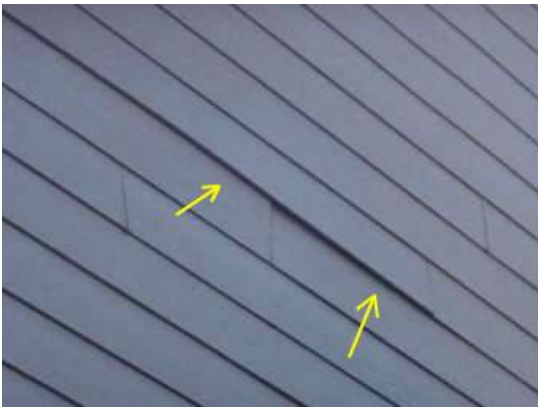
Photo 3-1

3) *Repair/Replace* - Sections of siding are loose at the second story above the front door. Recommend that a qualified person repair, replace or install siding as necessary.

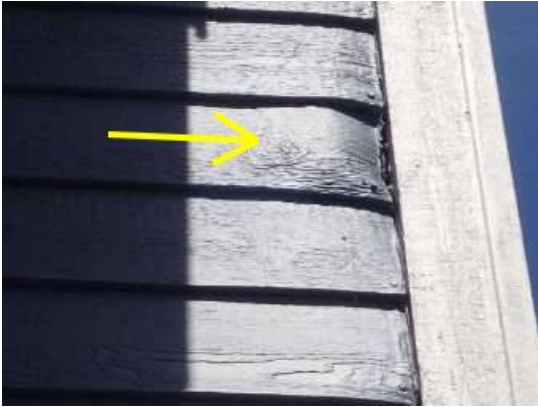
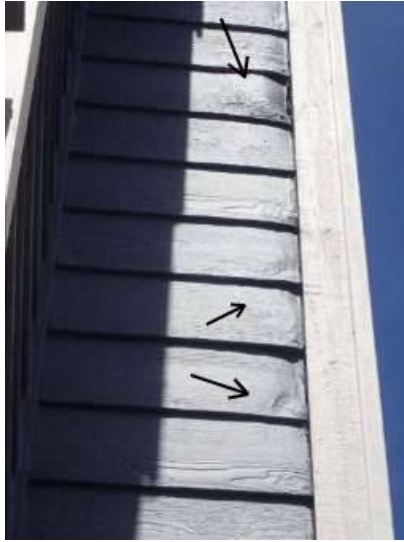
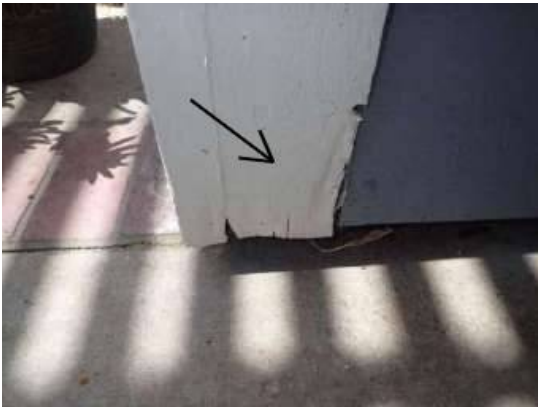
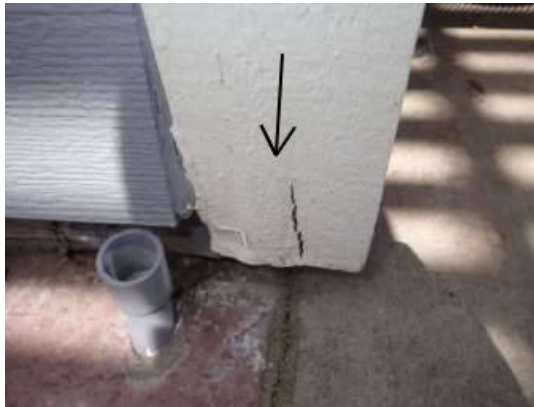
4) *Repair/Replace* - Moisture damage was found at sections of siding and trim generally located in the backyard and chimney. Conducive conditions for rot should be corrected (e.g. wood-soil contact, reverse perimeter slope, missing or damaged flashing). Recommend that a qualified structural pest contractor evaluate the structure in its entirety. Make any necessary repairs per standard building practices. All rotten wood should be replaced.

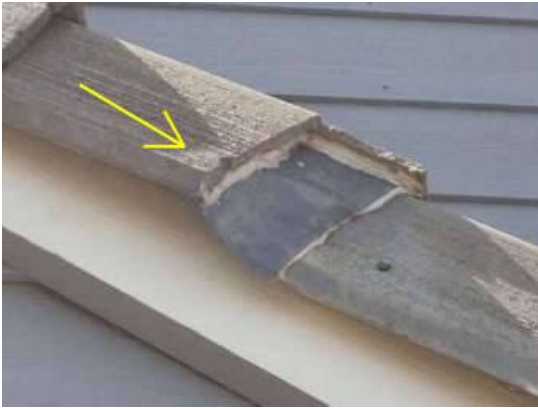
Photo 6-1

6) *Repair/Maintain* - Some concrete roof tiles were broken (backyard roof edge near chimney), missing (roof edge at exterior storage closet) and Lifting (roof to wall flashing above the front door). Leaks may occur as a result. This is a conducive condition for wood-destroying organisms. Recommend that a qualified roofer replace tiles or make repairs as necessary.

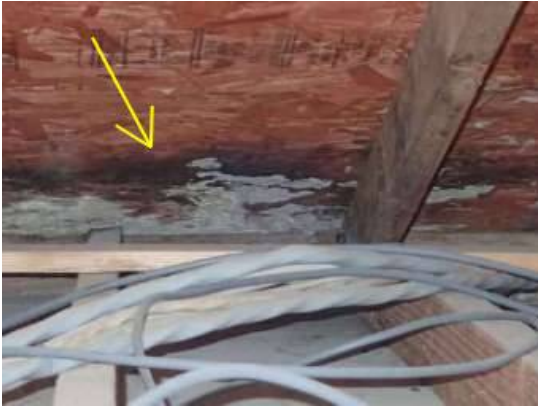
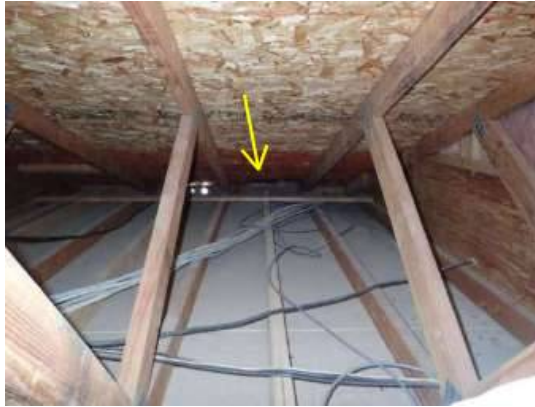
7) *Repair/Replace, Evaluate, Monitor* - What appeared to be past water stains were visible on the roof structure in the attic above the garage at the backyard eave. However, no elevated levels of moisture were found at these stains during the inspection. The stains may have been caused by a past leak. Recommend asking the property owner about past leaks and have a qualified roofing contractor evaluate and repair as necessary.

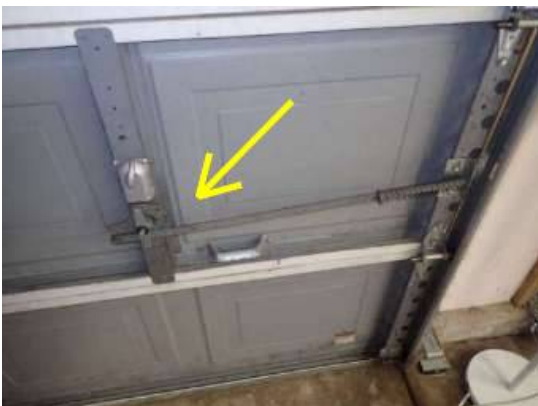
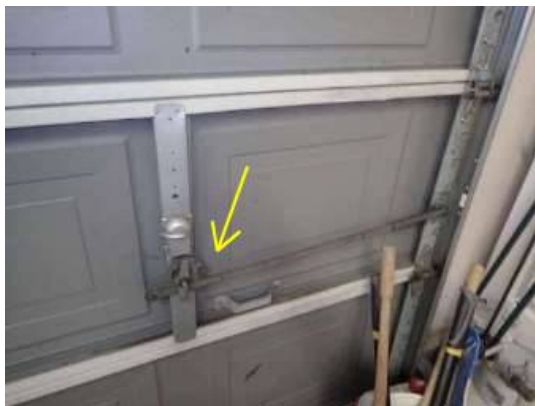
9) *Safety, Repair/Maintain* - The garage vehicle doors have automatic openers installed, and the manual lock mechanisms on the doors have not been permanently disabled. The automatic opener can be damaged, or injury can occur if the automatic door opener is operated with the manual lock engaged. A qualified person should disable or remove the lock mechanism per standard building practices.

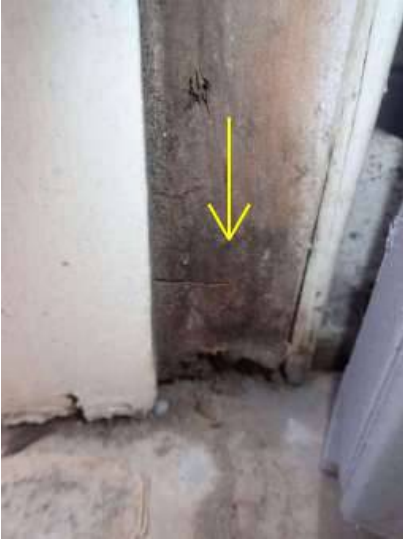
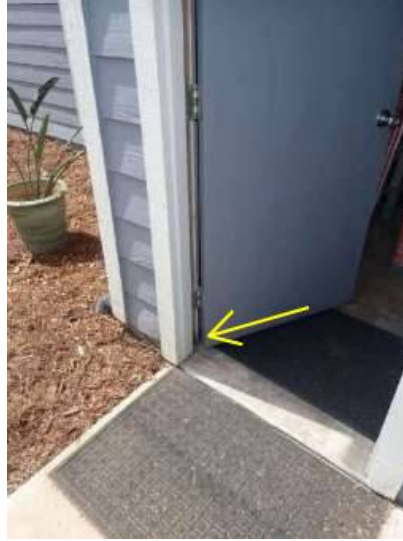
10) *Repair/Replace* - Moisture damage was found in the exterior door jambs. Recommend that a qualified structural pest contractor evaluate and repair as necessary. All rotten wood should be replaced.

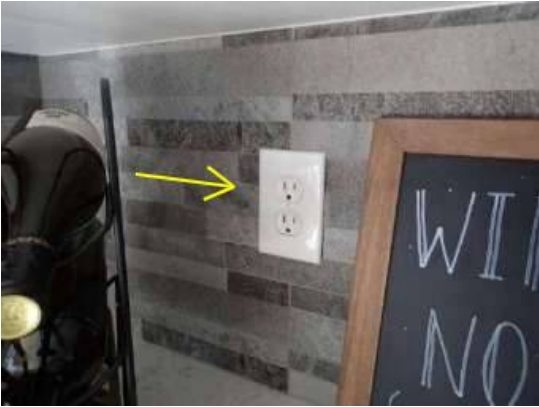
Photo 11-1

11) *Safety, Repair/Replace* - An electric receptacle (outlet) and/or the box in which it was installed is loose and/or not securely anchored located in the kitchen. Wire conductors can be damaged due to repeated movement and/or tension on wires, or insulation can be damaged. This is a shock and fire hazard. Recommend that a qualified electrician repair as necessary.

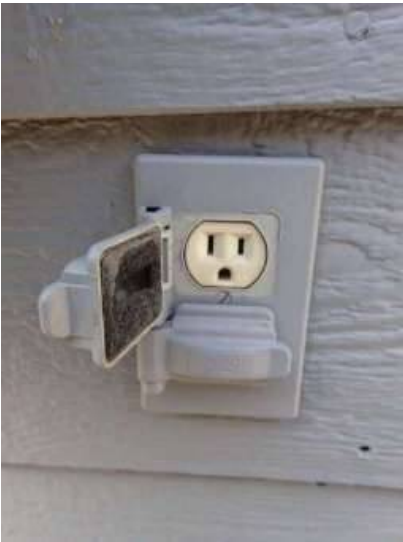
Photo 12-1

12) *Safety, Repair/Replace* - An electric receptacle (outlet) at the exterior has no visible ground fault circuit interrupter (GFCI) protection, or the inspector was unable to determine if GFCI protection was present. If not GFCI-protected, receptacles in wet areas pose a shock hazard. Recommend that a qualified electrician evaluate and install GFCI protection if necessary and per standard building practices. General guidelines for GFCI-protected receptacles include the following locations:

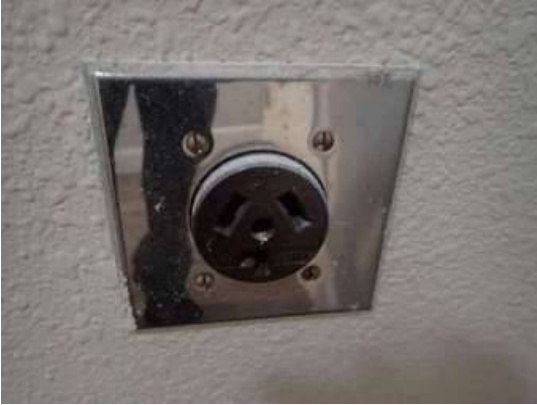
Photo 13-1

13) *Safety, Repair/Replace* - A 3-slot receptacle (outlet) was installed for the clothes dryer. Most modern clothes dryers use both 120 and 240 volts (120 for timers and motors, and 240 for heating elements) and either require or are more safely installed with a 4-slot receptacle. With 3-conductor wiring, the ground wire rather than a neutral wire is used to carry the return current back for the 120 volt leg. The clothes dryer's metal frame can become energized if the neutral wire becomes loose at the receptacle or panel. While 3-wire clothes dryer circuits were allowed prior to 1996 and are commonly found, they are considered unsafe due to the risk of shock. Recommend that a qualified electrician convert this to a 4-wire circuit. Note that this may require installing a new circuit wire from the panel to the clothes dryer location.

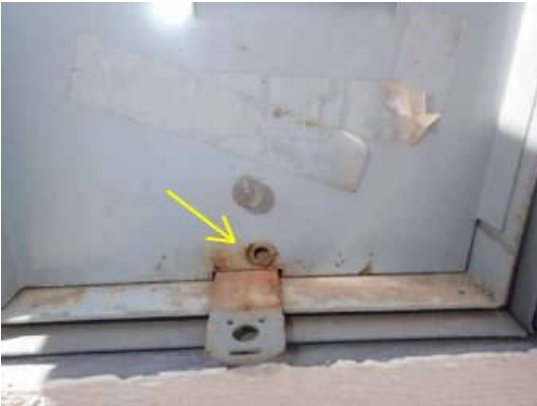
Photo 14-1

14) *Minor Defect* - The screw that attaches the cover or dead front to the main electrical panel is missing or not installed. Recommend installing screws where missing so the cover or dead front is secure. Only screws with blunt tips approved for this purpose should be installed, so wiring inside the panel is not damaged. Because energized wires may be located directly behind screw holes, the client should consider having a qualified electrician replace missing screws.

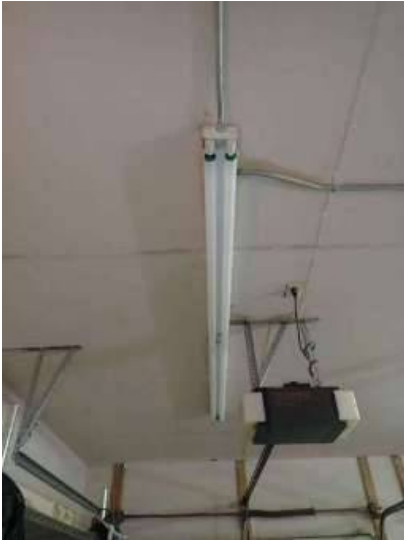
Photo 15-1

15) *Evaluate* - A light fixture in the garage is inoperable (didn't turn on when nearby switches were operated). Recommend further evaluation by replacing bulbs and/or consulting with the property owner. If replacing bulbs doesn't work and/or no other switch(es) can be found, then recommend that a qualified electrician evaluate and repair or replace light fixtures as necessary.

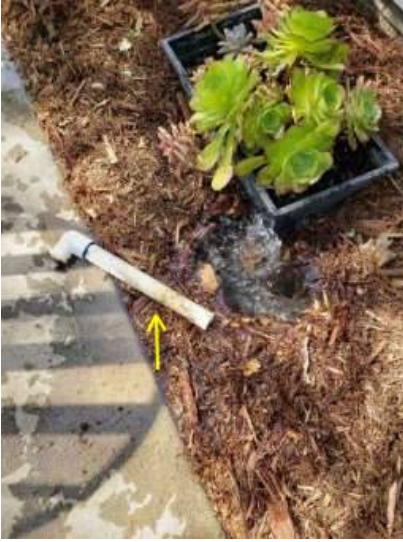
Photo 16-1

16) *Repair/Maintain, Evaluate* - A sprinkler line is damaged in the back yard below the formal dining room window. Excess amounts of water are discharged during operation. Recommend having a qualified person repair per standard building practices.

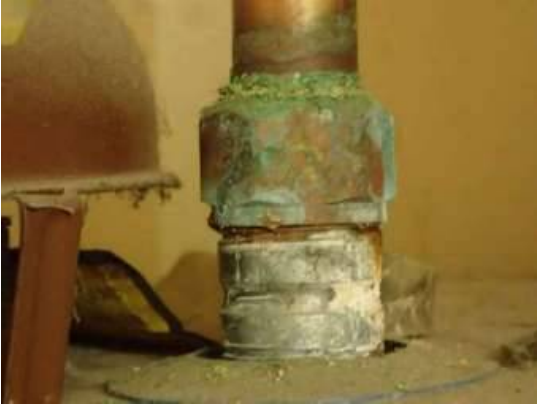
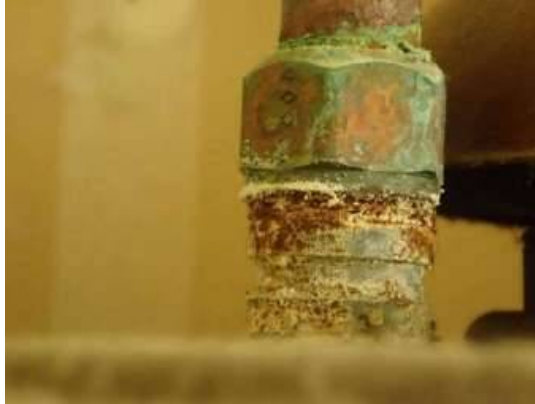
17) *Repair/Replace, Evaluate* - Corrosion or rust was found at the supply pipes or fittings. This can indicate past leaks, or that leaks can occur in the future. Recommend that a qualified plumber evaluate and replace components or make repairs as necessary.

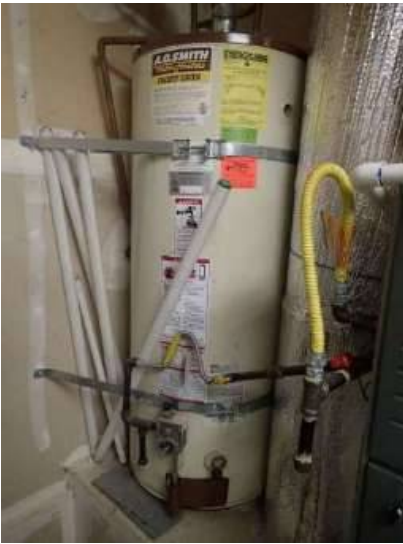
Photo 18-1

18) *Comment* - The estimated useful life for most water heaters is 8-12 years. This water heater appeared to be beyond this age and/or its useful lifespan and may need replacing at any time. Recommend budgeting for a replacement in the near future, or considering replacement now before any leaks occur. The client should be aware that significant flooding can occur if the water heater fails. If not replaced now, consider having a qualified person install a catch pan and drain or a water alarm to help prevent damage if water does leak.

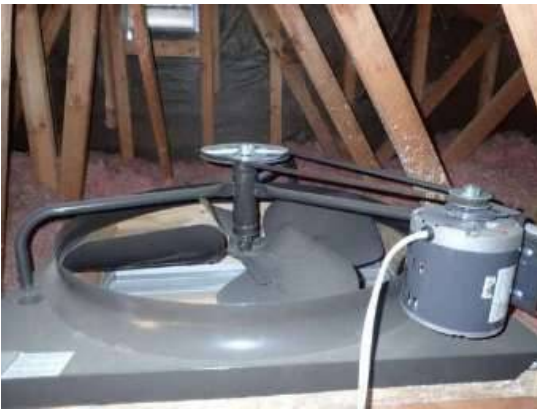
Photo 19-1

19) *Safety, Repair/Replace* - No guard was present at the whole house fan to prevent injury by coming in contact with the fan's blades and/or belt. This is a potential safety hazard. Recommend that a qualified person install a guard as necessary to prevent injury.

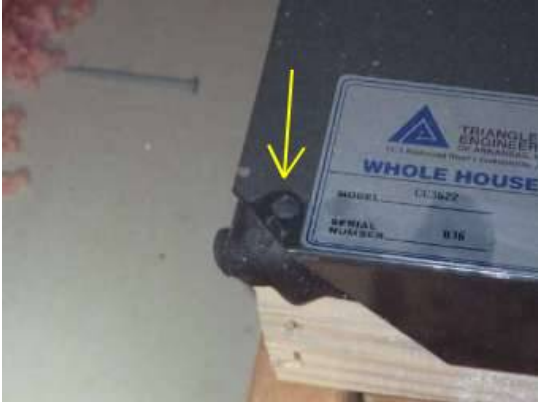
Photo 20-1

20) *Repair/Maintain* - The whole house fan installation was substandard due to missing fasteners. Currently the fan is sitting on a wood framed base and not fully installed. The fan can shift during operation causing damage. Recommend that a qualified contractor evaluate and repair per the manufacturer's specifications.

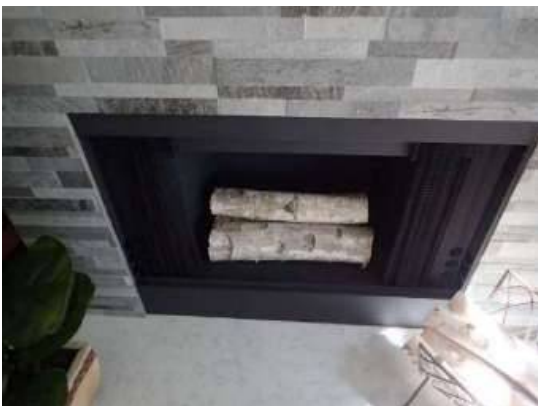
Photo 21-1

21) *Safety, Repair/Maintain, Evaluate* - A wood-burning fireplaces or stoves were found at the property. When such devices are used, they should be professionally inspected and cleaned annually to prevent creosote build-up and to determine if repairs are needed. The National Fire Protection Association states that a "Level 2" chimney inspection should be performed with every sale or transfer of property with a wood-burning device. Recommend consulting with the property owner about recent and past servicing and repairs to all wood-burning devices and chimneys or flues at this property. Recommend that a qualified specialist evaluate all wood-burning devices and chimneys, and clean and repair as necessary. Note that if a wood stove insert is installed, it may need to be removed for such an evaluation. For more information, search for "chimney inspection" at: <https://www.reporthost.com/?CSIA>

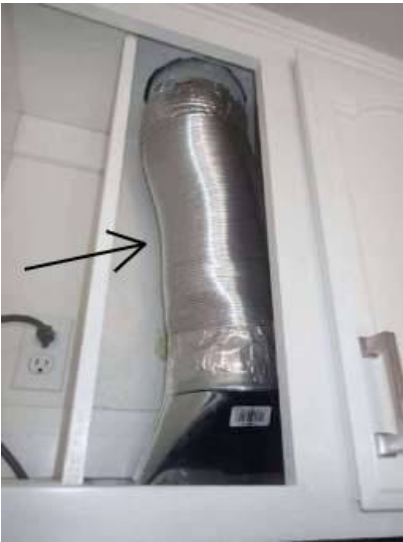
Photo 22-1

22) *Repair/Replace, Evaluate* - The exhaust duct is substandard and made from a non approved corrugated material. The duct serving a hood should have a smooth interior surface, be air tight and equipped with a backdraft damper. Ducts serving range hoods shall not terminate in an attic, crawl space or areas inside the building. Recommend having a qualified HVAC contractor evaluate and make repairs per standard building practices.

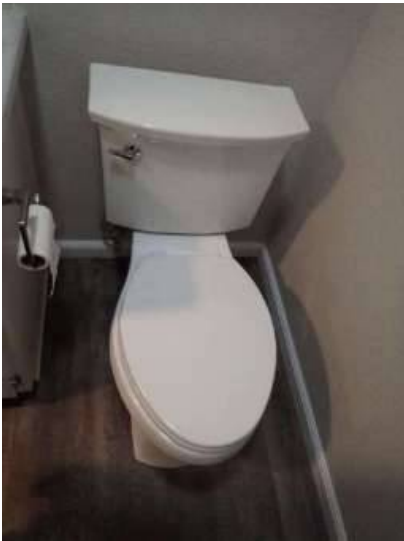
Photo 23-1

23) *Repair/Replace, Evaluate* - The toilet in the downstairs hall bathroom is loose where it attached to the floor. Leaks can occur. Flooring, the sub-floor or areas below may get damaged. Sewer gases can enter living spaces. Recommend that a qualified contractor remove the toilet for further evaluation and repair if necessary. A new wax ring should be installed and toilet should be securely anchored to the floor to prevent movement and leaking.

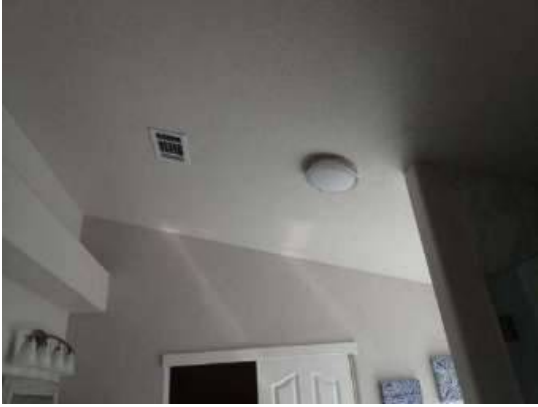
Photo 24-1

24) *Repair/Replace* - The master bathroom does not have an exhaust fan installed. Moisture can accumulate and result in mold, bacteria or fungal growth. Even if the bathroom has a window that opens, it may not provide adequate ventilation, especially during cold weather when windows are closed or when wind blows air into the bathroom. Recommend that a qualified contractor install exhaust fans per standard building practices where missing in bathrooms with showers or bathtubs.

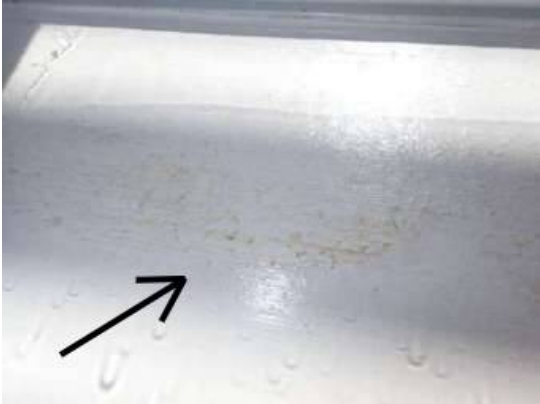
25) *Repair/Replace, Evaluate* - Water stains or evidence of leaking were found in the living room windows. Stains are visible in the window seal and gaps noted in the windows frame. Recommend that a qualified window contractor evaluate all three windows and repair as necessary.

Photo 25-1 Close up of window sill staining.

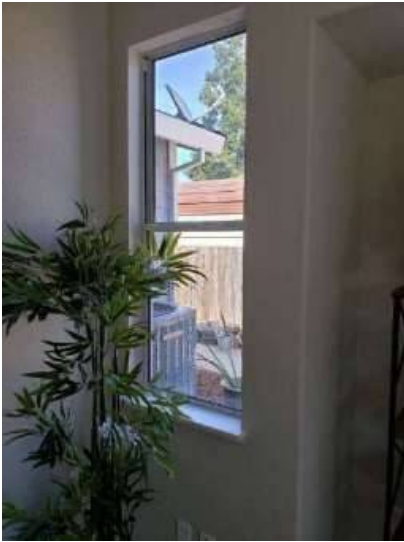
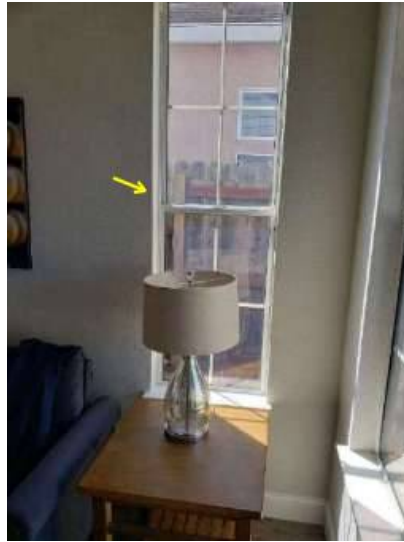
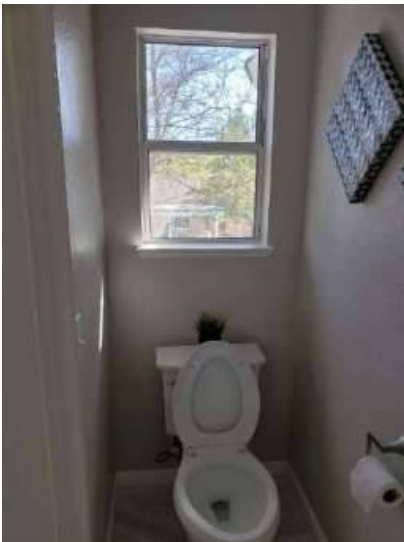
26) *Repair/Replace, Evaluate* - Latch mechanisms used to unlatch the windows for exterior cleaning are damaged. This can pose a safety risk since if these latches were to fail the windows can swing open causing damage. Recommend that a qualified window contractor repair latches as necessary.

Located:
Living room
Family room
Kitchen nook
Master bathroom above the toilet

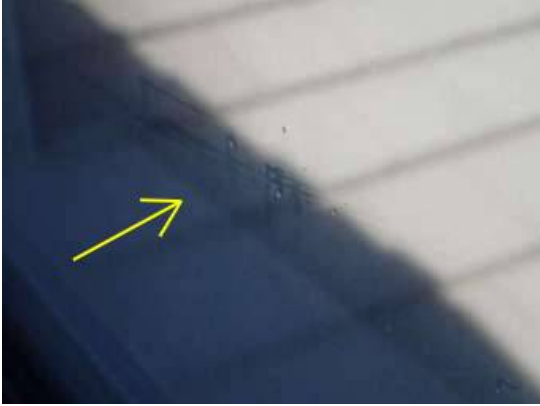
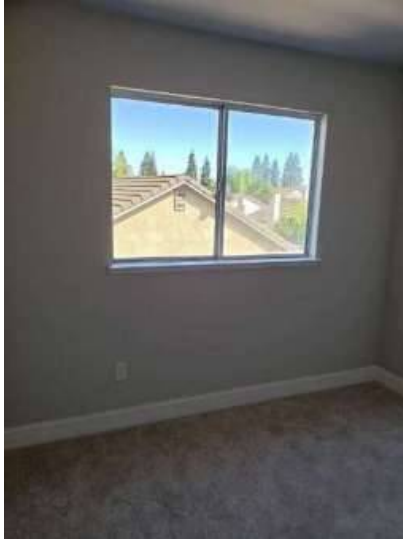
27) *Repair/Replace, Evaluate* - Condensation or staining was visible between multi-pane glass in the upstairs back right spare bedroom window. This usually indicates that the seal between the panes of glass has failed or that the desiccant material that absorbs moisture is saturated. As a result, the view through the window may be obscured, the window's R-value will be reduced, and accumulated condensation may leak into the wall structure below. Recommend that a qualified contractor evaluate and repair windows as necessary. Usually, this means replacing the glass in window frames.

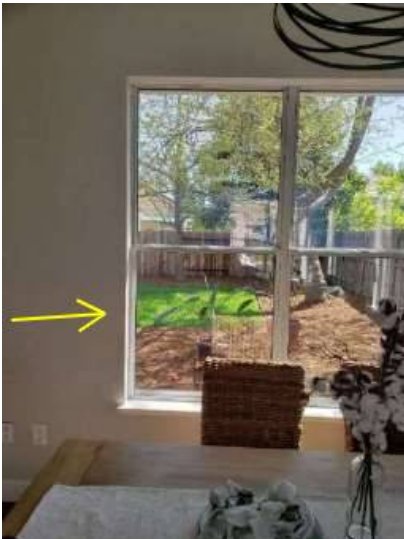
Photo 29-1

29) *Repair/Maintain* - The sash-side spring mechanisms in the formal dining room window are broken, loose or disconnected. The window will not stay open as a result. Recommend that a qualified window contractor or service technician repair as necessary so windows open and close easily, and stay open without support.
